INDOOR AIR QUALITY ASSESSMENT

**Bridgewater Raynham Regional High School
Guidance Suite
415 Center Street
Bridgewater, Massachusetts**

Prepared by:
Massachusetts Department of Public Health
Bureau of Environmental Health
Indoor Air Quality Program
October 2017

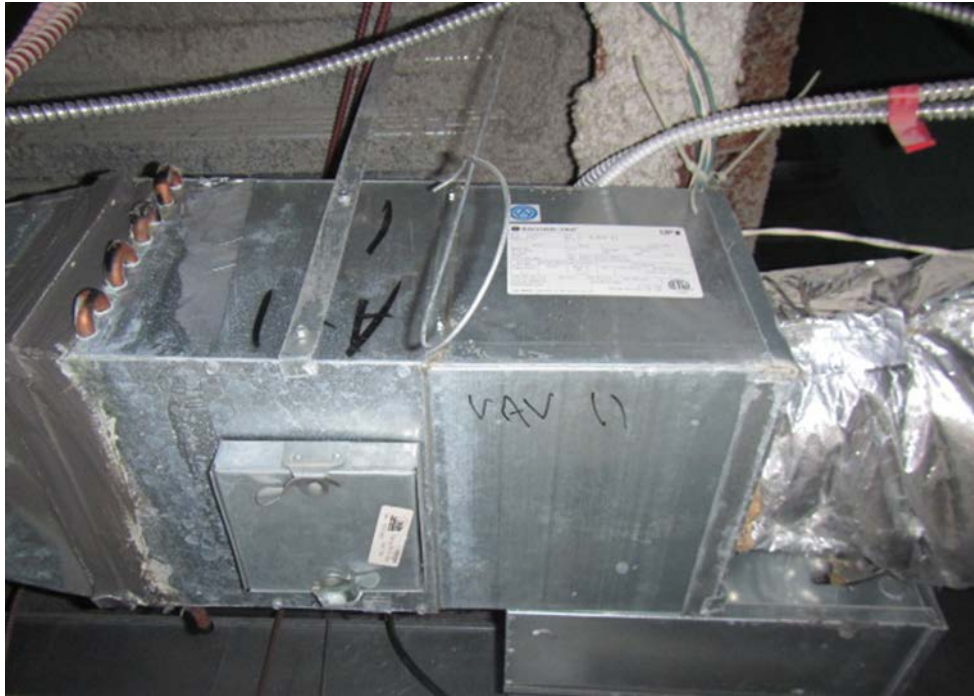
Picture 1

The heating, ventilation and air conditioning (HVAC) system consists of rooftop handling units (AHUs) controlled by a computerized program. The units supply conditioned air to occupied spaces via ductwork to local variable air volume (VAV) boxes above the ceiling of the Guidance suite (Picture 1). Conditioned air is delivered to spaces via wall or ceiling vents (Picture 2). Air is drawn into the above ceiling plenum through grates (Picture 3) and returned back to the rooftop units via ductwork. The system also provides AC. At the time of assessment airflow in office A143 appeared to be weak/minimal.

VAV box above ceiling tiles in Guidance suite

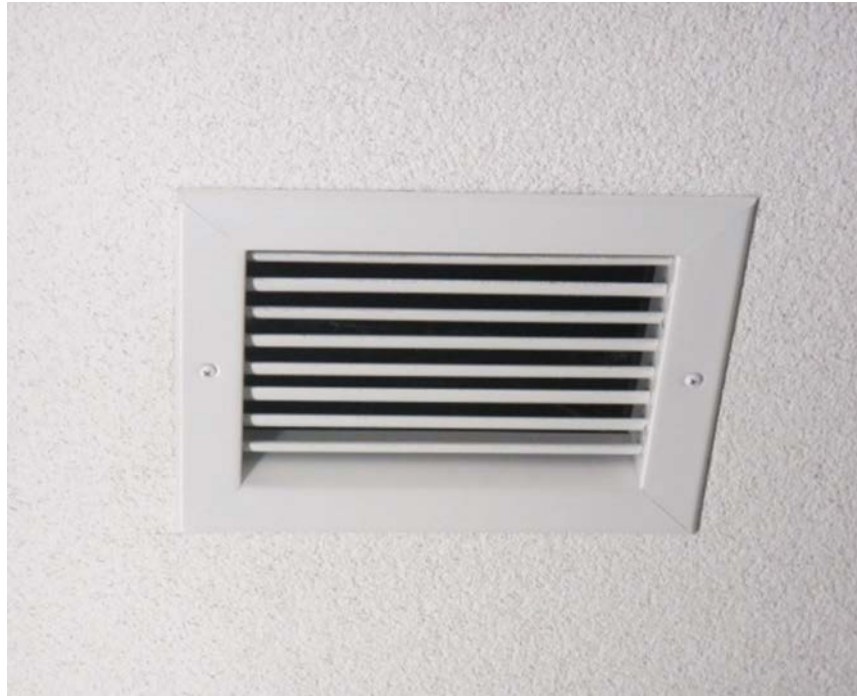
Picture 3

Ceiling-mounted return vent

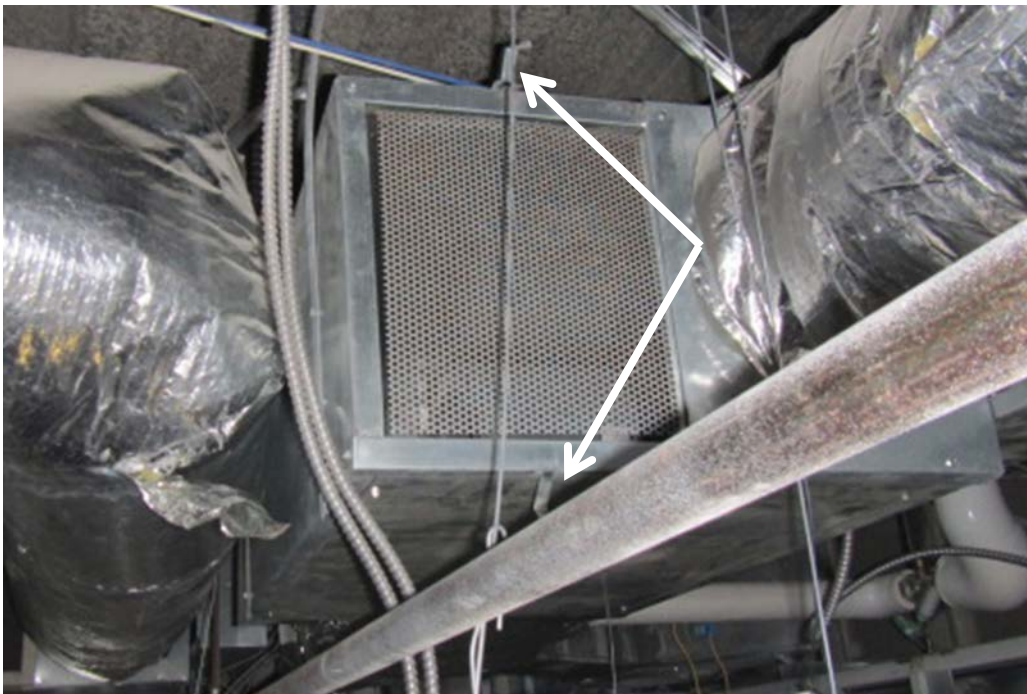
Picture 4

It was also reported that maintenance staff had removed/discarded VAV filters prior to the MDPH assessment (Picture 4), therefore they could not be evaluated. BEH/IAQ staff returned to the Guidance suite two days later on October 13, 2017 and found the VAV filters had been replaced (Picture 5). It should be noted that this type of VAV box filters provide minimal filtration. The rooftop AHU (Picture 6), where fresh air is drawn into the system, contains two rows of pleated high-efficiency filters (Pictures 7 and 8). The MDPH recommend that AHUs be outfitted with pleated filters of a Minimum Efficiency Reporting Value (MERV) of 8, which are adequate in filtering out pollen and mold spores (ASHRAE, 2012). In addition, filters should be changed 2-4 times a year or in accordance with the manufacture's recommendations. The AHUs at BRRHS are MERV 8 and are reportedly changed 3 times per year.

VAV box with filter removed, note loose clips at top and bottom (arrows)

3. Continue to change filters in HVAC units included VAV boxes a minimum of twice per year (e.g., between heating/cooling seasons) or as per the manufacturer's instructions. Upgrade filters in AHU to MERV 8 or higher.

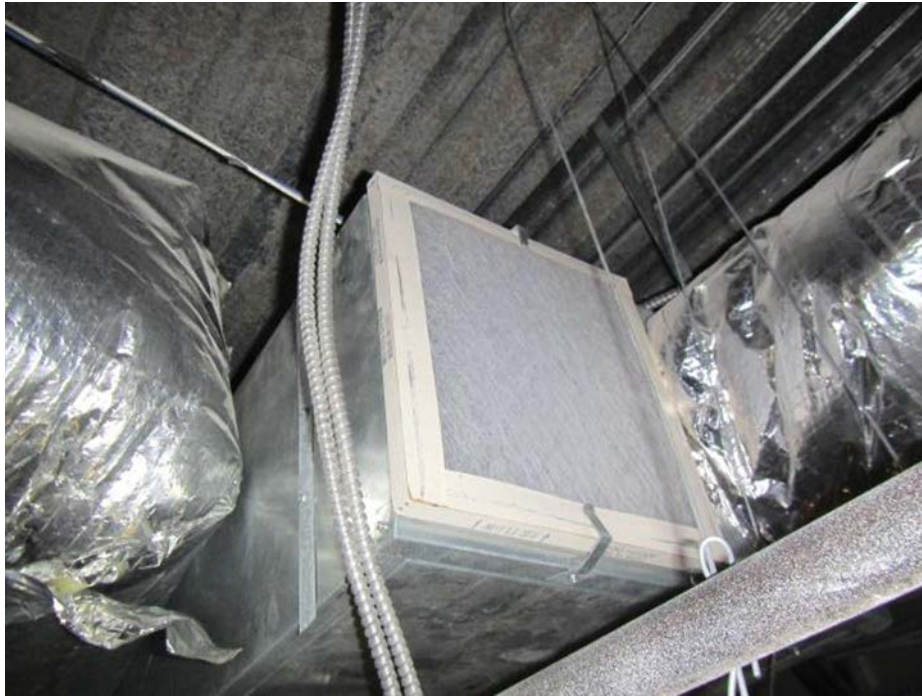
Picture 5

Mesh filter on VAV box in Guidance suite

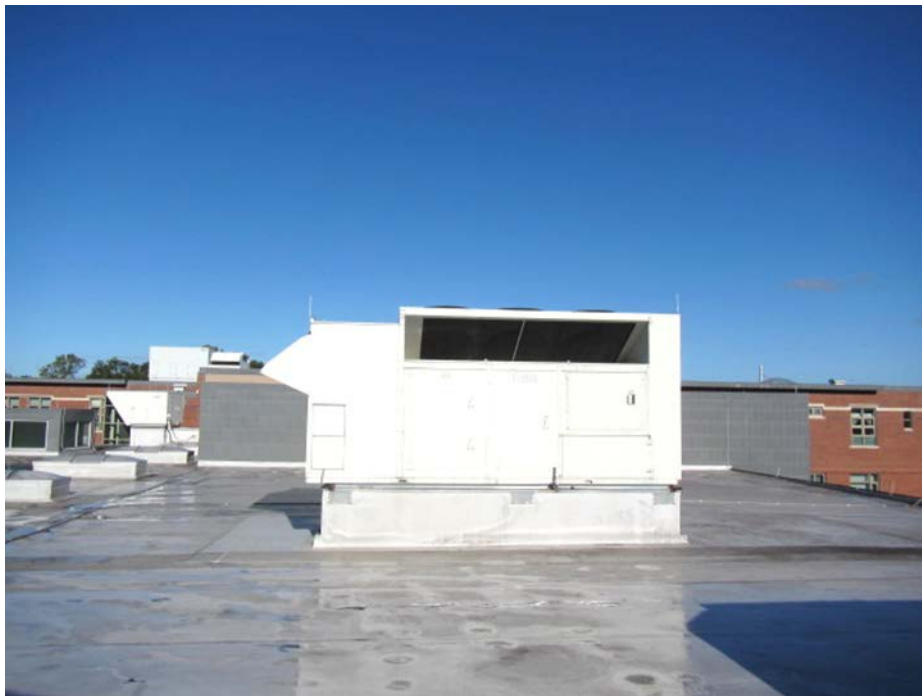
Picture 6

Rooftop AHU for Guidance suite

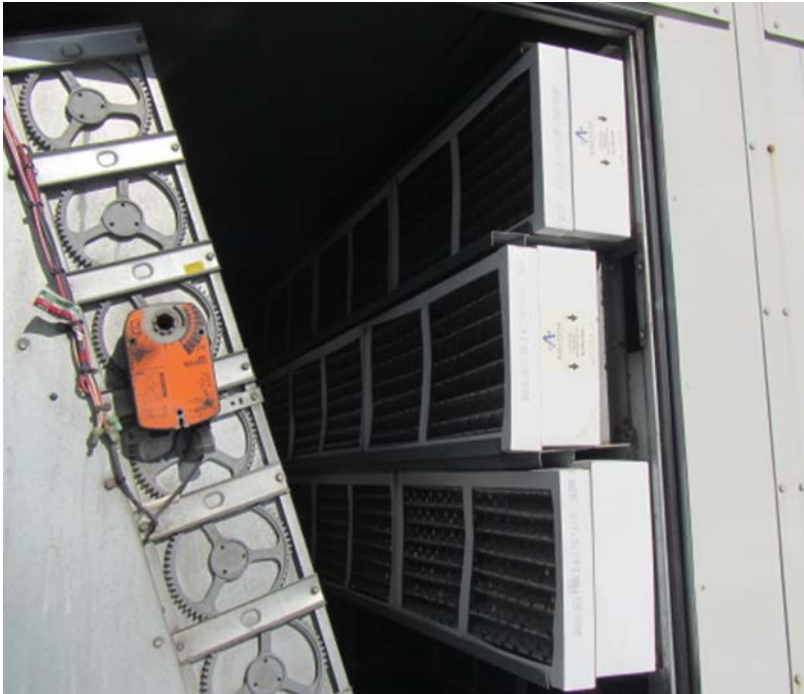
Picture 7

Two rows of pleated filters in rooftop AHU

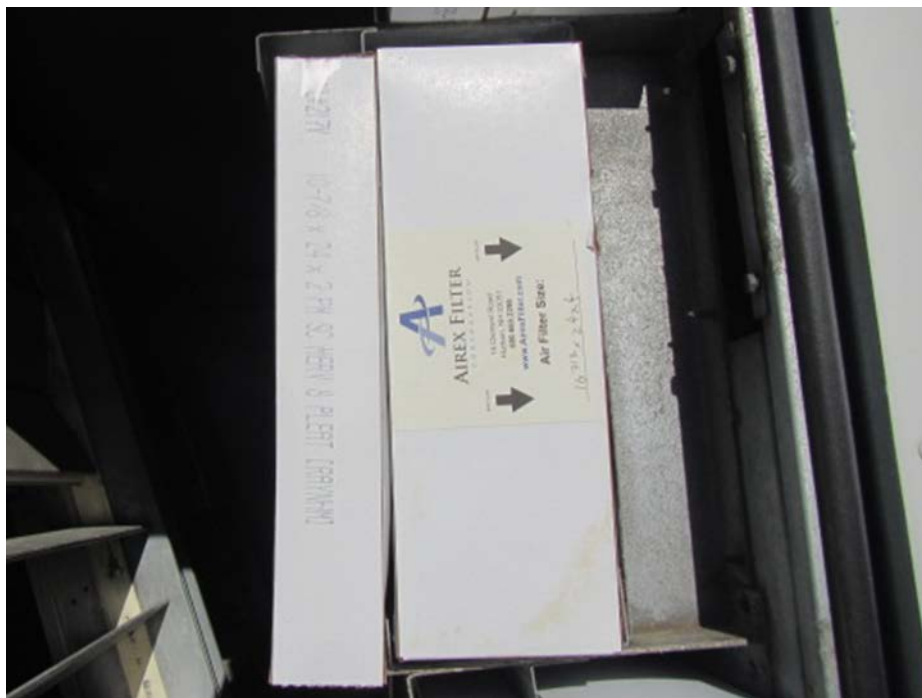
Picture 8

MERV 8 Filters in rooftop AHU

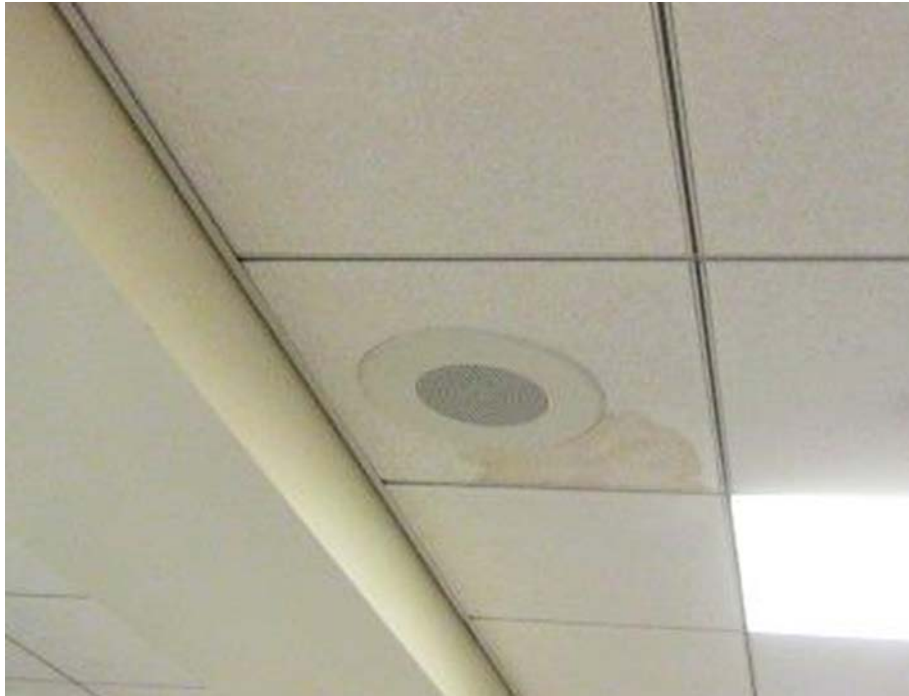
Picture 9

It was reported that over the summer a roof drain had clogged resulting in water infiltration into the Guidance suite and that school maintenance staff began drying/water extraction methods within 24 hours of detection. No current water damage and or visible mold growth was observed on building materials in the space or above ceiling tiles, with the exception of one stained tile (Picture 9).

Stained ceiling tile

5. Replace water-damaged ceiling tiles after leaks are discovered and repaired.
6. Make repairs to loose/hanging insulation above ceiling near the Guidance reception desk (Picture 10) to prevent condensation and dust/debris.

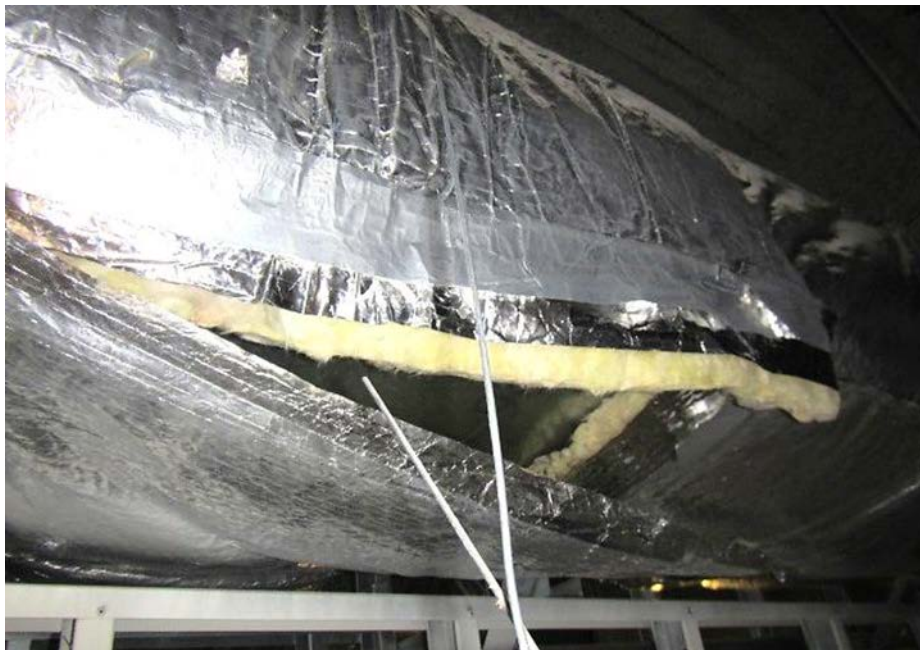
Picture 10

Loose/hanging insulation material was noted around ductwork above the ceiling near the Guidance reception desk (Picture 10). Exposed metal/ductwork can be prone to condensation,

which can wet ceiling tiles and create conditions for mold growth. In addition, the exposed insulation can be a source of dust and debris.

Loose/hanging insulation around ductwork above ceiling near Guidance reception desk
